## FACE INVESTIGATION

**SUBJECT:** Lineman at Hydroelectric Utility was Asphyxiated when the Safety Rope Attached to his Harness Became Entangled in a Revolving Turbine Shaft.

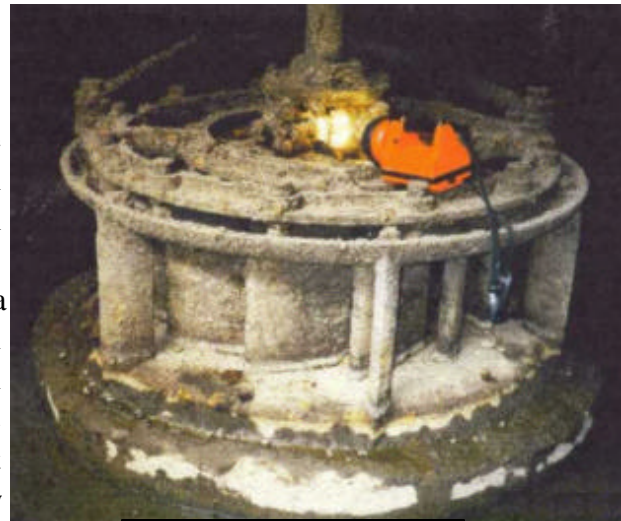
Figure 2. View of turbine.

Discussion: The generator and turbine had been installed about 75 years before the incident, and was not equipped with a braking mechanism that could completely stop the rotation of the turbine vanes during repair activities. Therefore, the turbine shaft continued to rotate while the victim was attempting to free the vanes.

### **Recommendation #1: Employers should install a locking brake which stops the rotation of hydroelectric turbines when maintenance and repair is necessary.**

Note: The utility company has installed a brake on the generator that could stop the rotation of the turbine. The brake was in place at the time of the on-site investigation.
